Stabilization of a wrecked and corroded aluminium aircraft

G.T. Bailey

Treloar Centre for Conservation, Australian War Memorial.

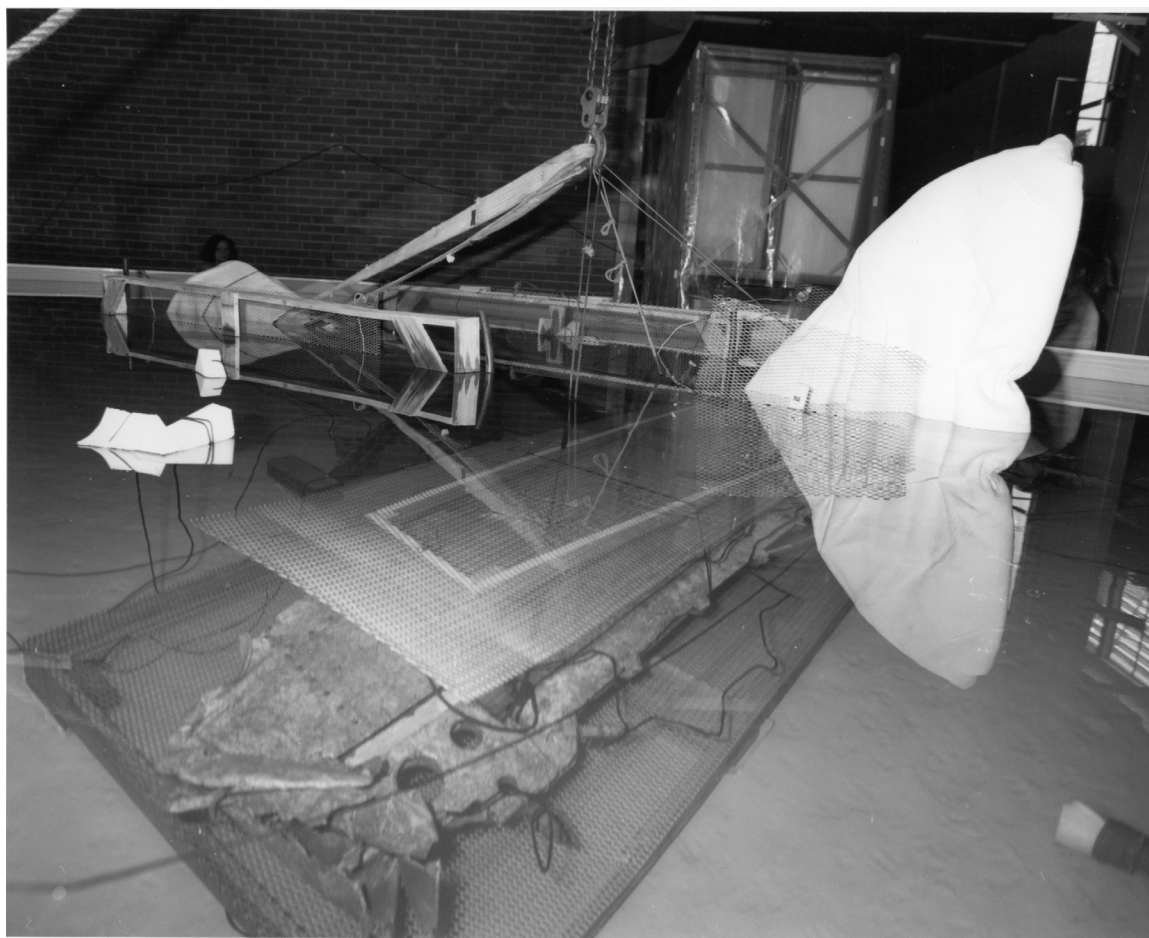
Figure 1. Oscar rear fuselage and empennage during treatment

At weekly intervals the rear fuselage was lifted out of the pool and inspected for progress of the treatment and unexpected corrosion development. After one month all ferrous corrosion and white and blue/green aluminium corrosion products had disappeared, and a thin layer of non-adherent black smut, assumed to be copper oxides, had settled on the rear fuselage. Biological activity had also appeared in the solution. No significant increase in either pH or chloride levels in solution were recorded, so the rear fuselage was removed and the black smut washed off.

The pool was drained, cleaned and refilled with clean water, and the rear fuselage re-immersed for one week to remove remaining traces of the first solution. The same potential as above was applied to the system. Upon removal from the pool again, the rear fuselage was encased in polyethylene and dehumidified for two weeks to completely dry it. During this period, flash rusting occurred on all ferrous parts. These were treated with 5% w/v Tannic acid in ethanol. The rear fuselage was then sprayed with Dinol AV5B inhibited wax to protect it from future corrosion.

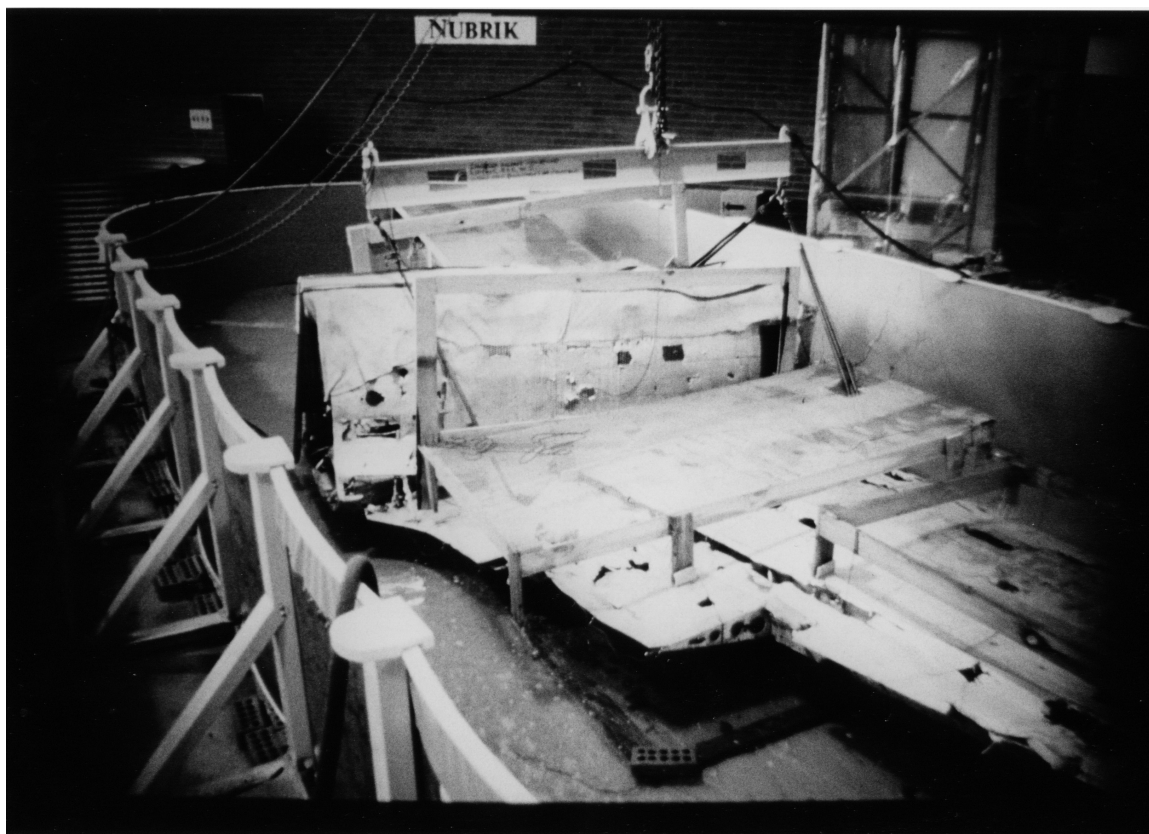
Figure 2. Oscar wing and cockpit section in the pool to check the position of the bottom anodes.

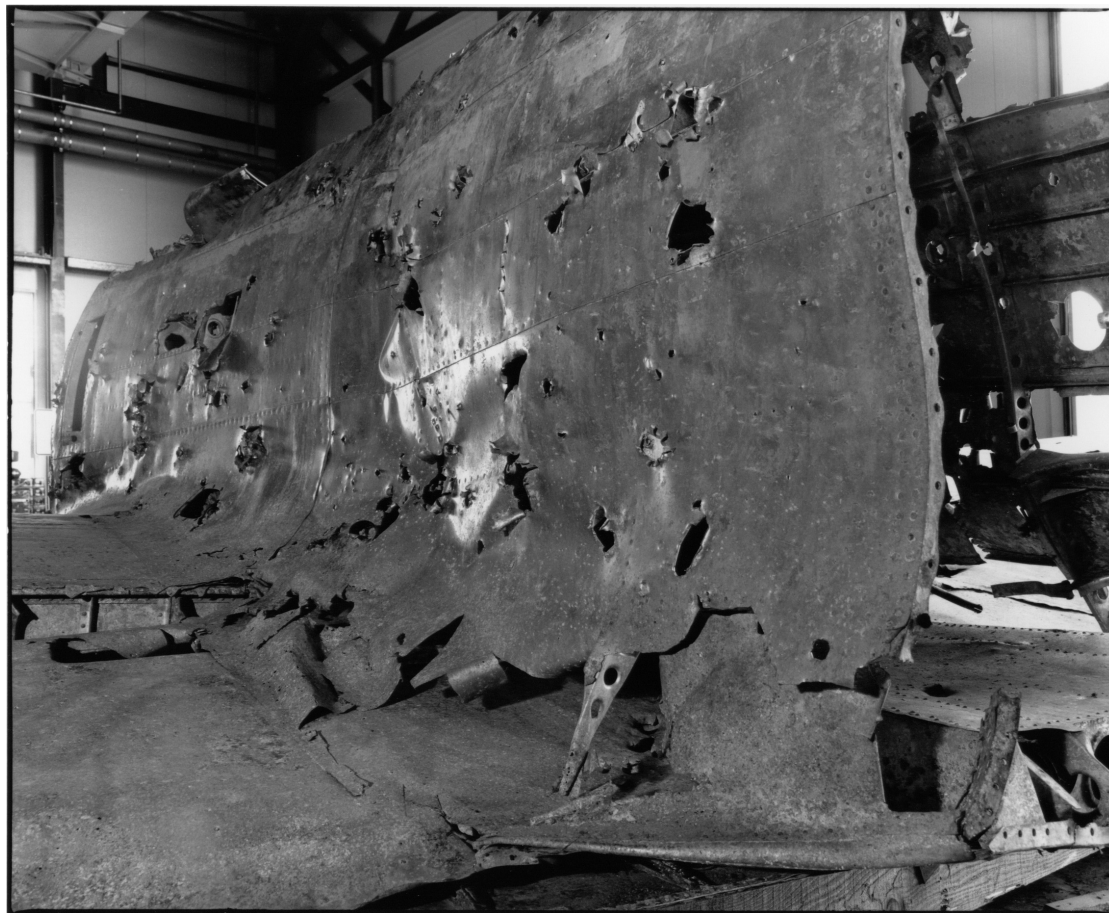
During the rinsing stage, it was noticed that small white spots were starting to appear on the wings. This indicated that pitting corrosion was occurring, suggesting that the potential of the system was not correct. All electrical connections were checked and found to be in order. The reference electrode was then checked and found to be giving inaccurate readings. This is thought to be due to contamination from biological growth blocking the ceramic frit. The correct potential was reapplied, and the section was left for another week. After removal, the wings were scrubbed to remove the remaining white corrosion products, and then dried, tannated and waxed in the same way as the tail section above. Figure 3 shows the wing/cockpit section after treatment.

Figure 3. Oscar cockpit section after treatment.

Contamination of the reference probe by biological material in the pool also caused an incorrect potential to be applied to the wing/cockpit section during the final rinsing stage. This resulted in some minor pitting of the aluminium.
